Remedial Investigation Report (Volume 1 of 2: Report)

Fieldstone Property
Consent Order

Docket No. HSA-CO 01/02-154

FIELDSTONE PROPERTY REMEDIAL INVESTIGATION REPORT

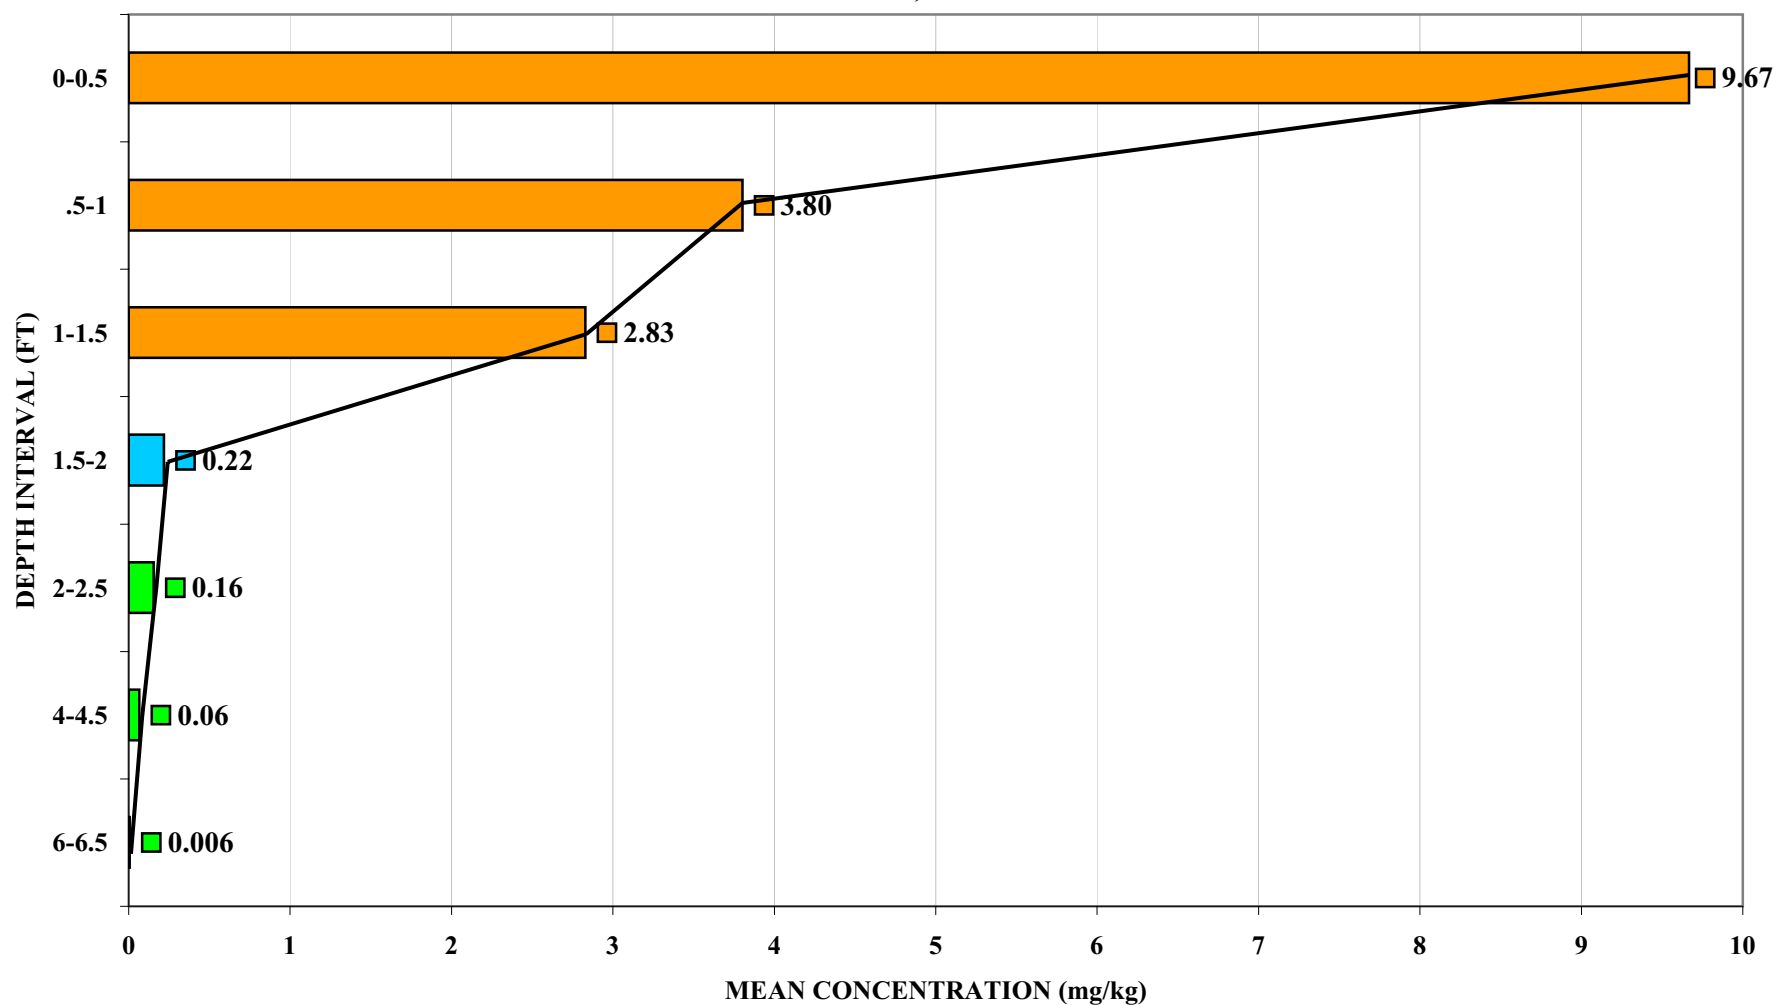
FIGURE 4-13
PCB-1260 SOIL DATA VERTICAL DISTRIBUTION
FIELDSTONE PROPERTY
ORANGE COUNTY, CALIFORNIA
